PROYECTO : ELABORACIÓN DE 03 EXPEDIENTES TÉCNICOS DE INSTITUCIONES EDUCATIVAS, DISTRITO DE PIURA-PROVINCIA DE PIURA-PIURA	COMPONENTE 03: REHABILITACIÓN DEL LOCAL DE LA INSTITUCIÓN EDUCATIVA PARCEMON Saldarriga-DISTRITO DE PIURA-PROVINCIA PIURA-REGIÓN GRAU	UBICACION: DEPARTAMENTO:PIURA PROVINCIA:PIURA DISTRITO:PIURA SECTOR:PACHITEA	CONSULTOR: CONSORCIO EL ALGARROBO	ESPECIALIDAD: ARQUITECTURA PLANO: DETALLE DE PERGOLA I	EQUIPO DE DISEÑO: ARQ. MARCO TRELLES CAP 14260 JEFE DE PROYECTO: ING. JOSE TALLEDO COVERAS REVISADO: APROBADO:	OBSERVACIONES FECHA	LAMINA: COMPONENTE 03 ARQUITECTURA DA-31
				DIBUJO: XIN-VILL ESCALA: 1/20 FECHA: SETIEMBRE 2019

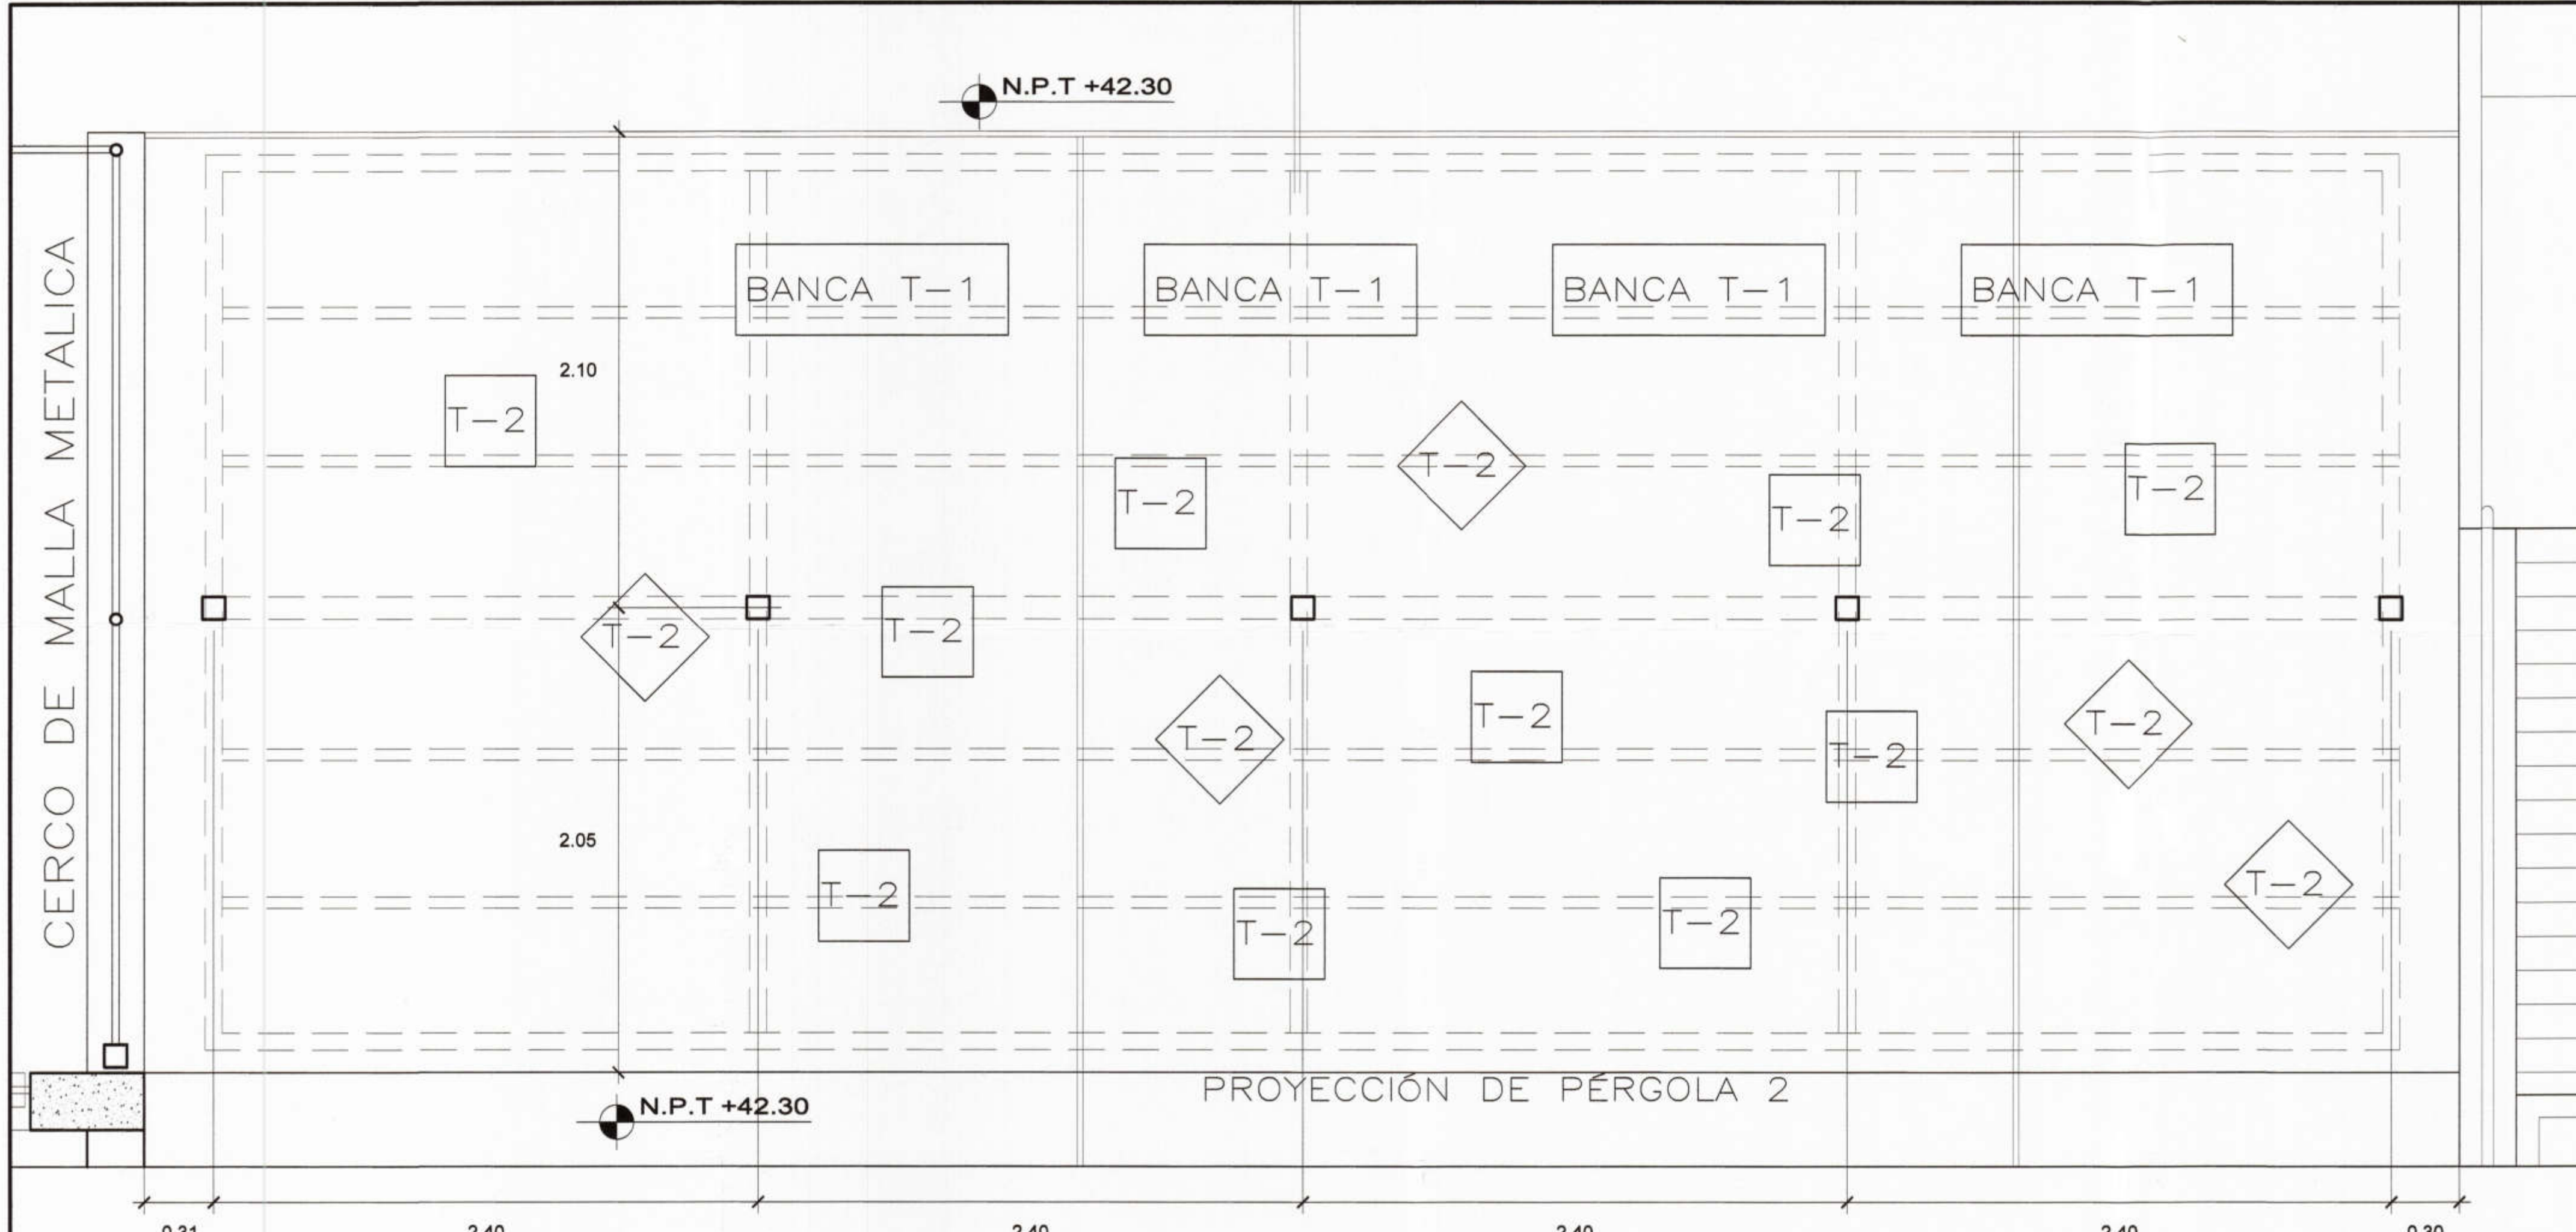
TUBO DE 50x100x2.5mm	TUBO DE 50x100x2.5mm	TUBO DE 50x100x2.5mm	TUBO DE 50x100x2.5mm
TUBO DE 40x60x2.5mm	TUBO DE 40x60x2.5mm	TUBO DE 40x60x2.5mm	TUBO DE 40x60x2.5mm
TUBO DE 40x60x2.5mm	TUBO DE 40x60x2.5mm	TUBO DE 40x60x2.5mm	TUBO DE 40x60x2.5mm
TUBO DE 100x100x2.5mm	TUBO DE 100x100x2.5mm	TUBO DE 100x100x2.5mm	TUBO DE 100x100x2.5mm
TUBO DE 40x60x2.5mm	TUBO DE 40x60x2.5mm	TUBO DE 40x60x2.5mm	TUBO DE 40x60x2.5mm
TUBO DE 40x60x2.5mm	TUBO DE 40x60x2.5mm	TUBO DE 40x60x2.5mm	TUBO DE 40x60x2.5mm
TUBO DE 50x100x2.5mm	TUBO DE 50x100x2.5mm	TUBO DE 50x100x2.5mm	TUBO DE 50x100x2.5mm
